**CORROSION CONDITION SURVEY  
OF U1020 MONTANA AVENUE OVERPASS-BILLINGS  
FOR  
MONTANA DEPARTMENT OF TRANSPORTATION  
WJE No. 2000.2547  
November 27, 2000**

CORROSION CONDITION SURVEY  
OF U1020 MONTANA AVENUE OVERPASS-BILLINGS  
FOR  
MONTANA DEPARTMENT OF TRANSPORTATION  
WJE No. 2000.2547  
November 27, 2000

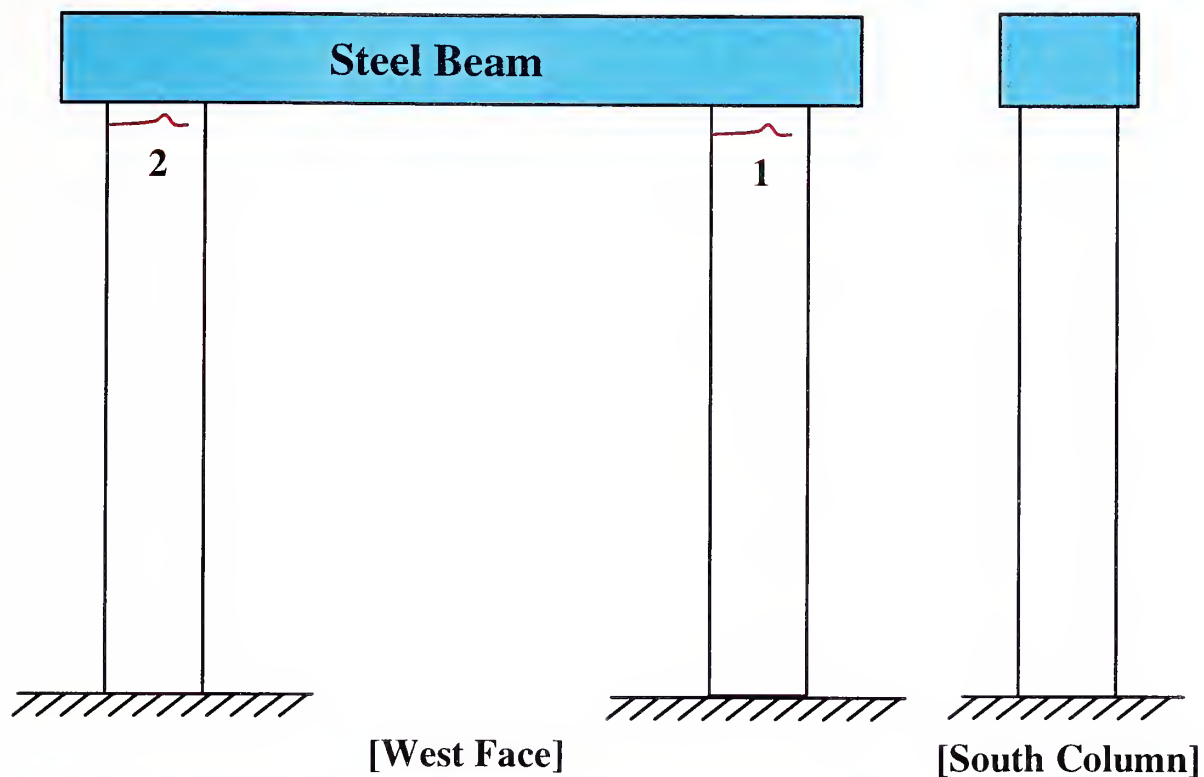
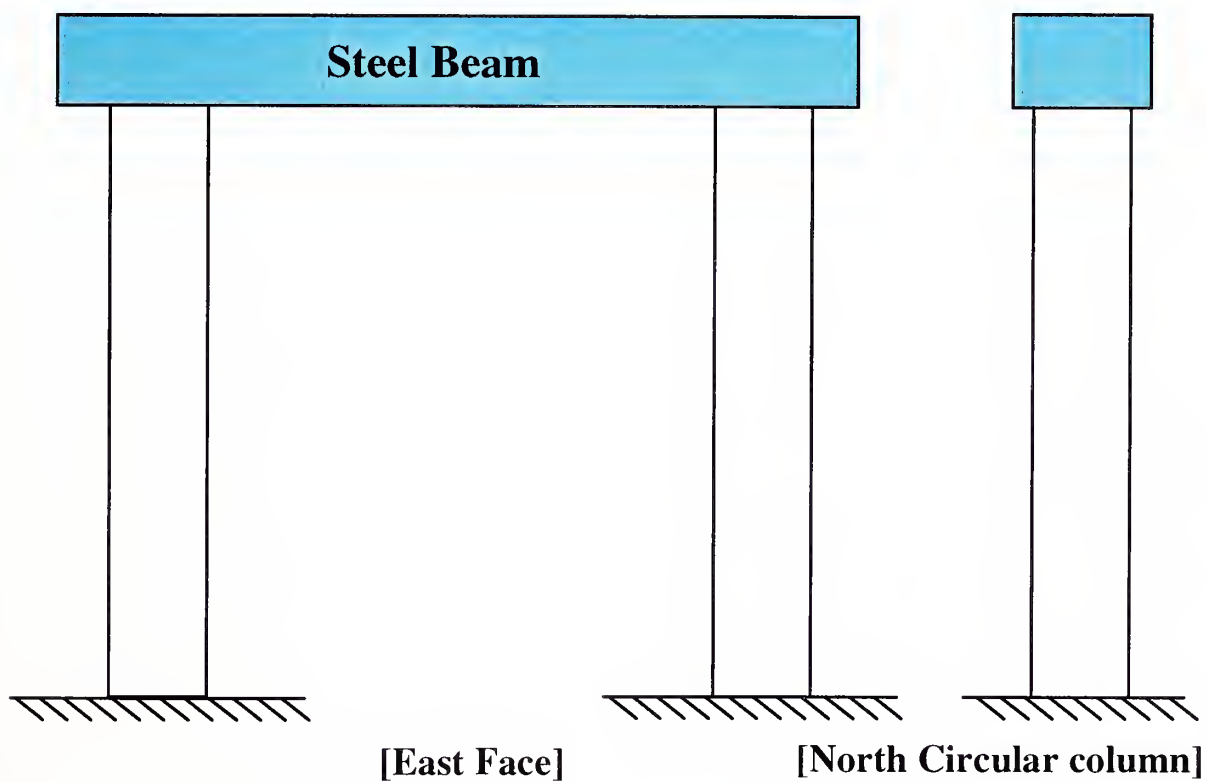
Figure 13A. Condition of Bent No. 14 (East Bound).

Damage	Location	Face	Description of Damage (No.)	Leakage Condition:
	Column	Circular	Cracks (1-2)	No deck above and exposed
	<b>Pattern cracking and large cracks on large surface area of both columns (North column appeared to be worse than South one).</b>			Test Performed: None

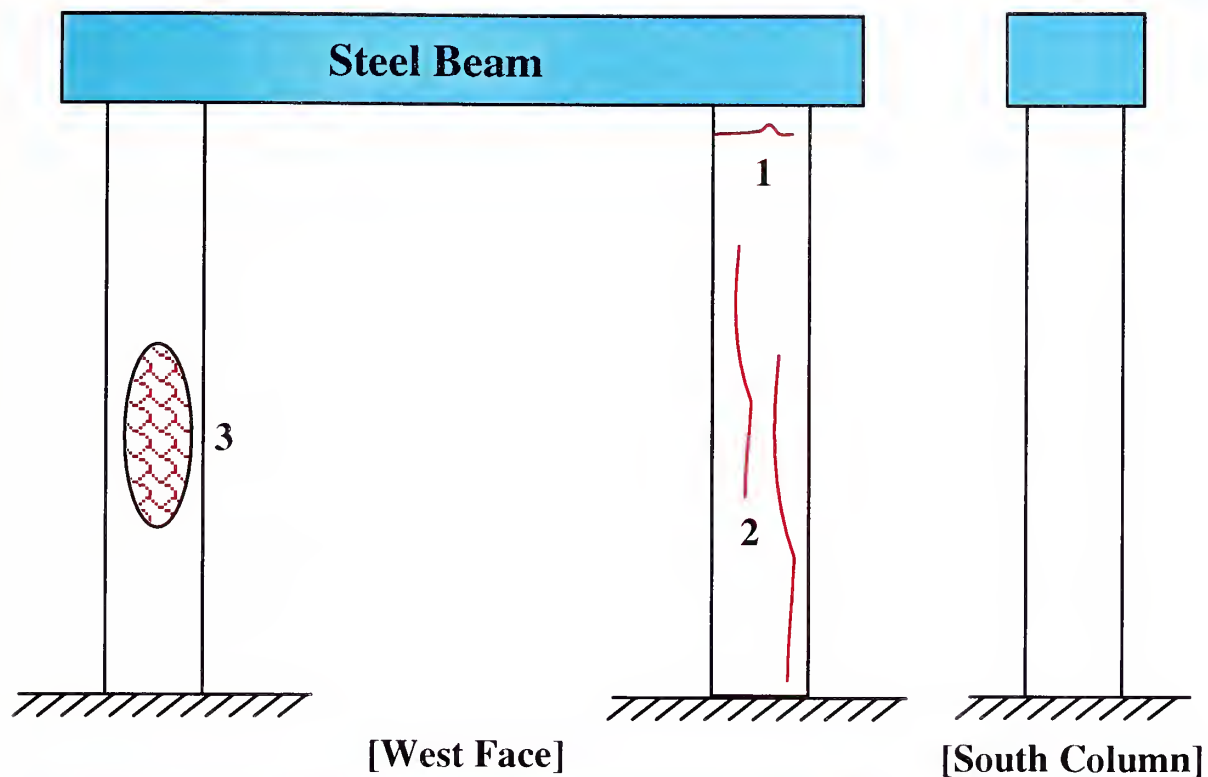
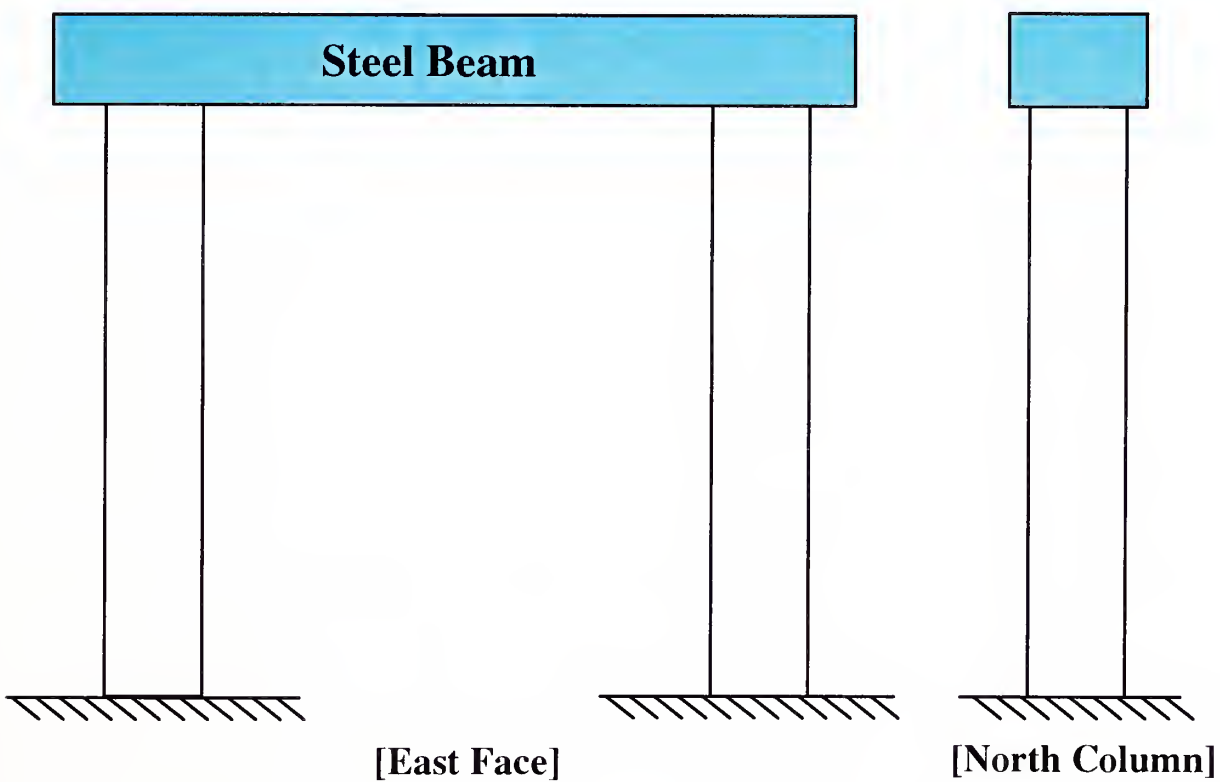
**Figure 14A. Condition of Bent No. 15 (East Bound).**

Damage	Location	Face	Description of Damage (No.)	Leakage Condition: No deck above and exposed  Test Performed: None
	Column	Circular	Cracks (1-2)	
	Column	Circular	Pattern cracking (3)

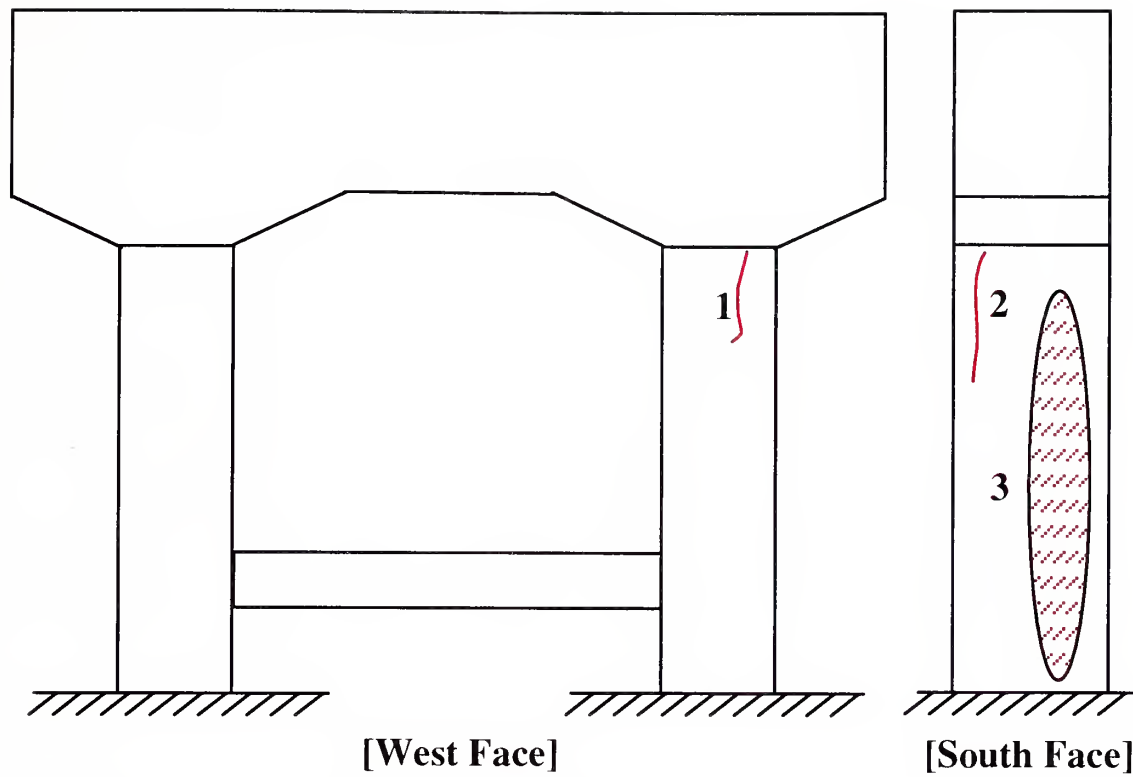
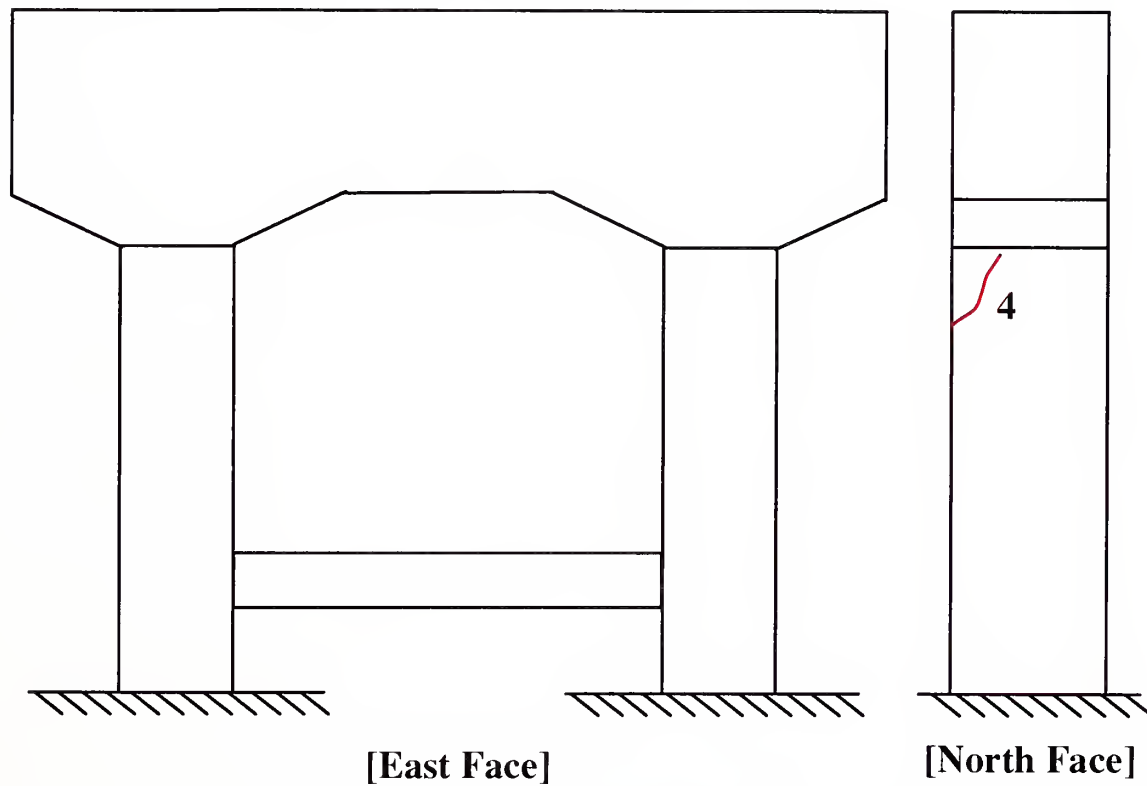
**Figure 15A. Condition of Bent No. 16 (East Bound).**

Damage	Location	Face	Description of Damage (No.)	Leakage Condition: No Leakage  Test Performed: None
	Column	West	Crack (1)	
	Column	South	Crack (2)	
	Column	South	Multiple cracks (3)	
	Column	North	Crack (4)

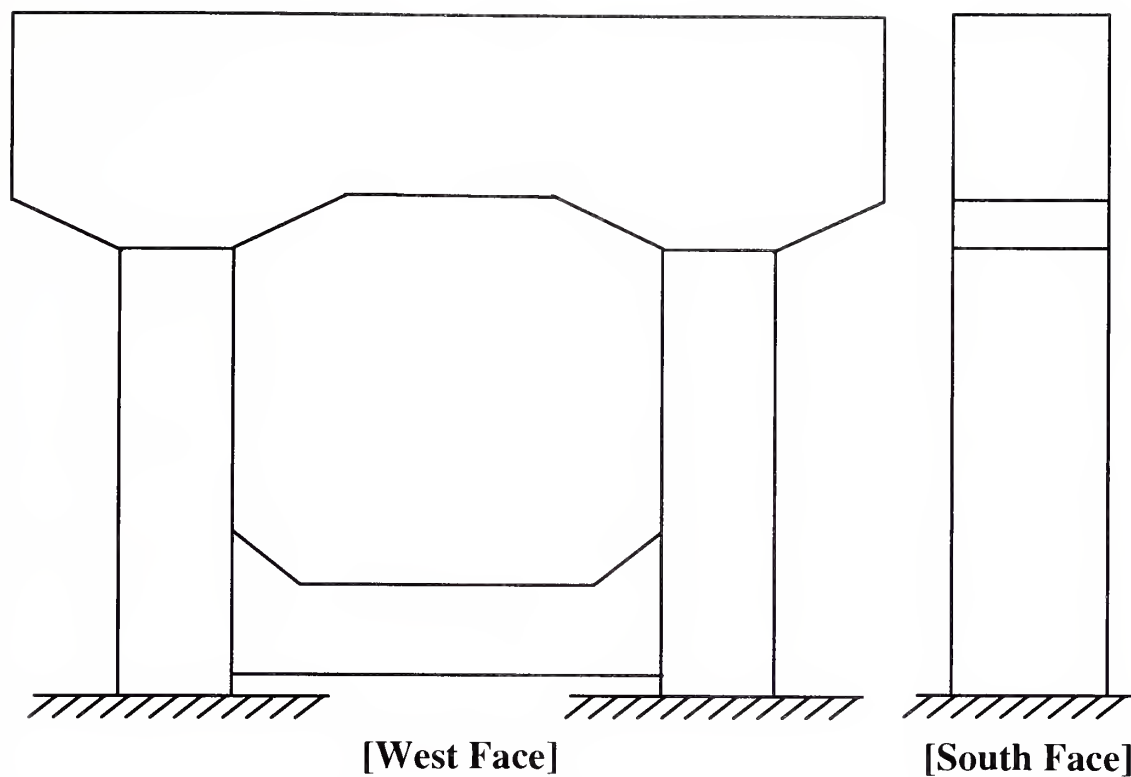
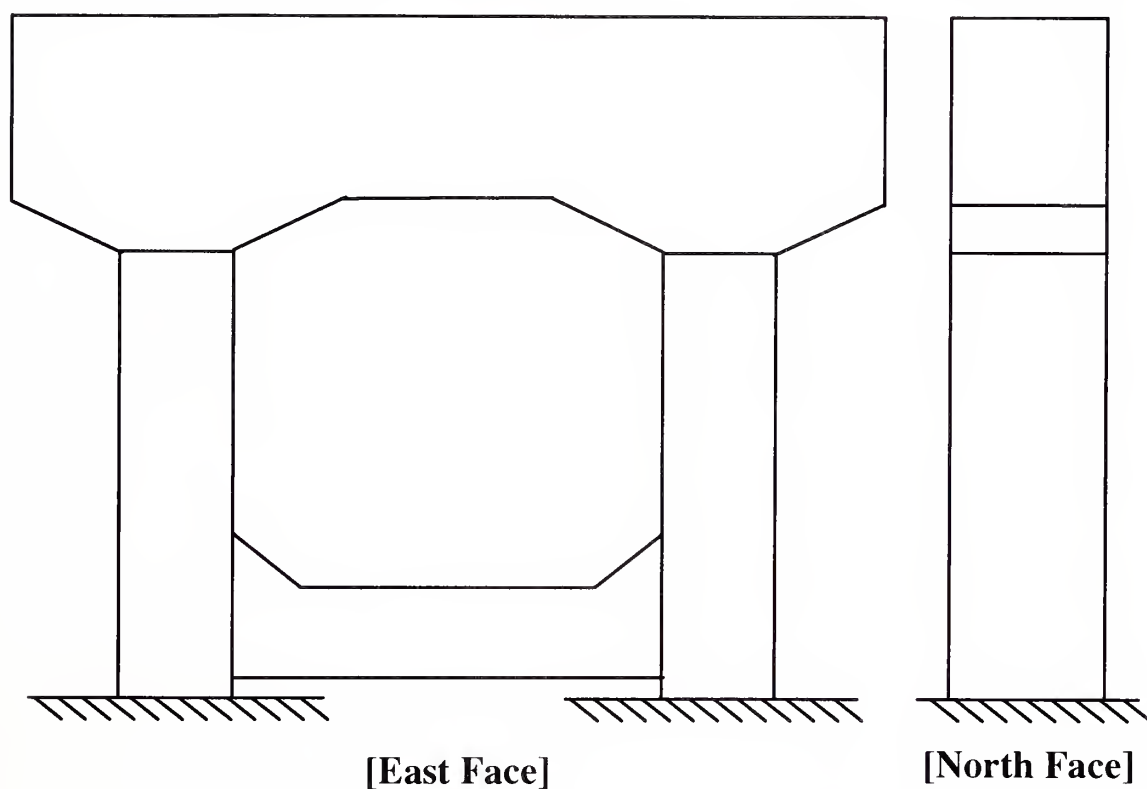
**Figure 16A. Condition of Bent No. 17 (East Bound).**

Damage	Location	Face	Description of Damage (No.)	Leakage Condition: No Leakage  Test Performed: None
			<b>No Damage Observed</b>

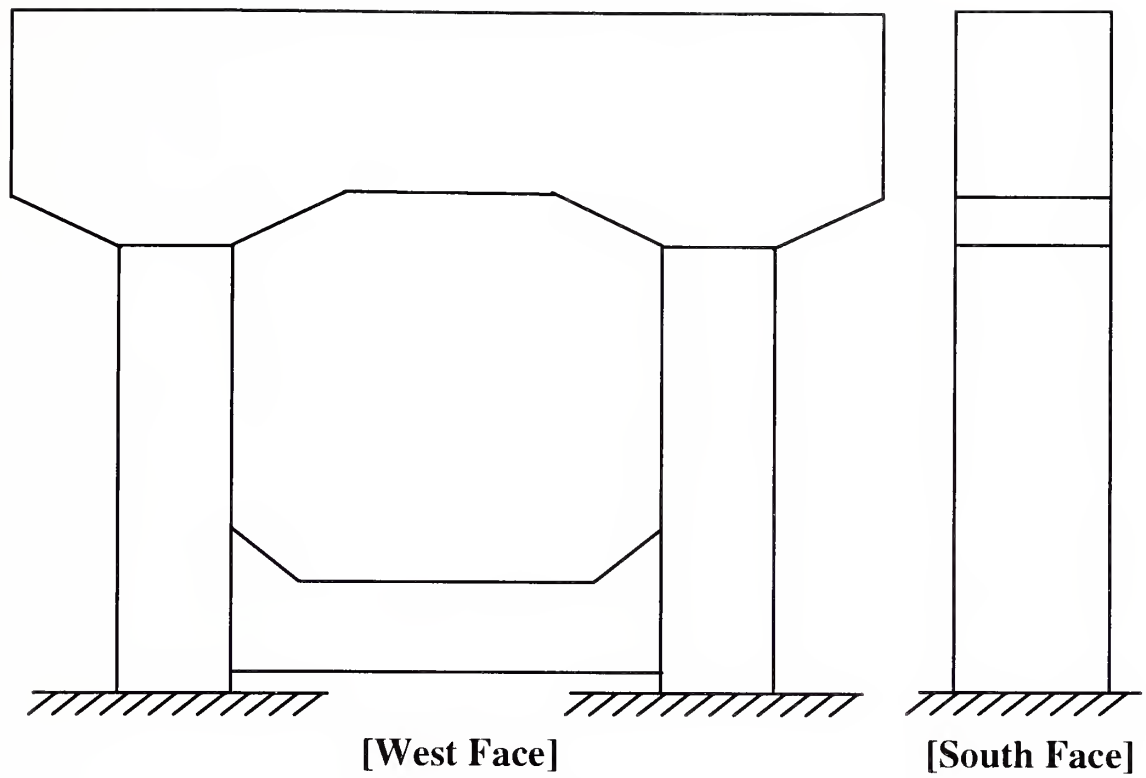
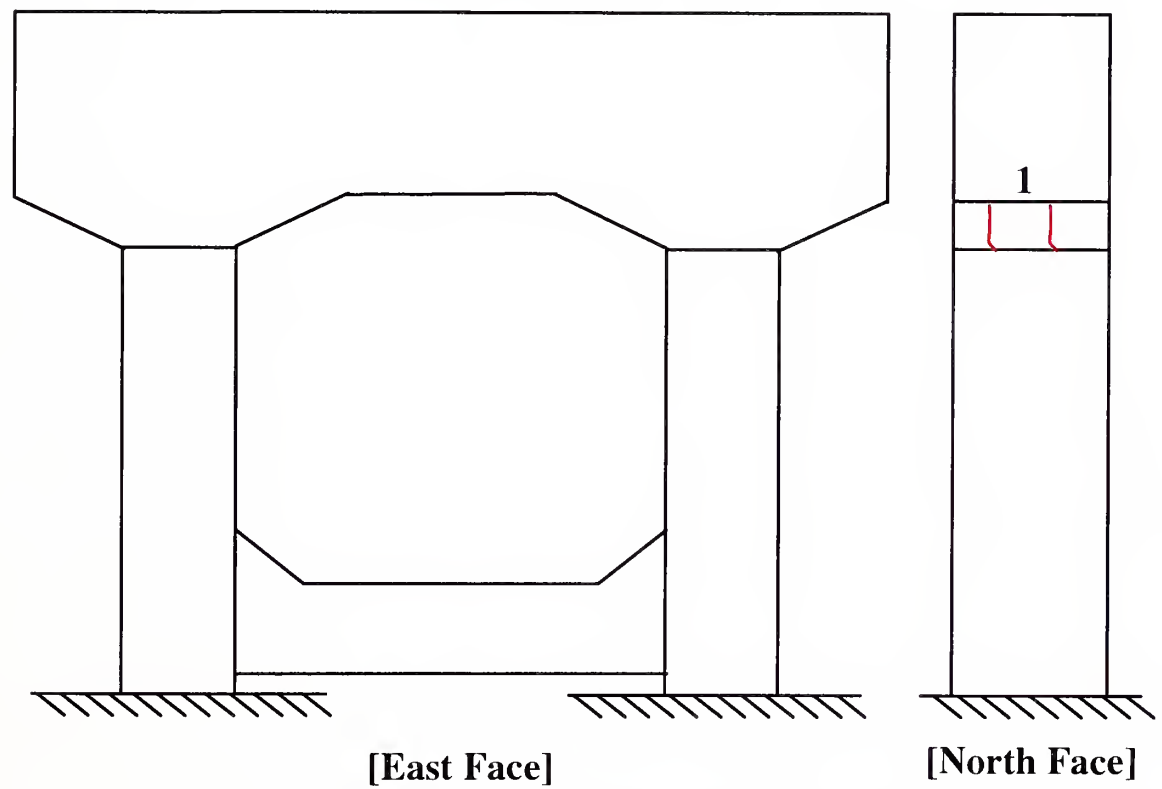
Figure 17A. Condition of Bent No. 18 (East Bound).

Damage	Location	Face	Description of Damage (No.)	Leakage Condition: No Leakage
	N. Col.	North	Two cracks (1)	
				Test Performed: None

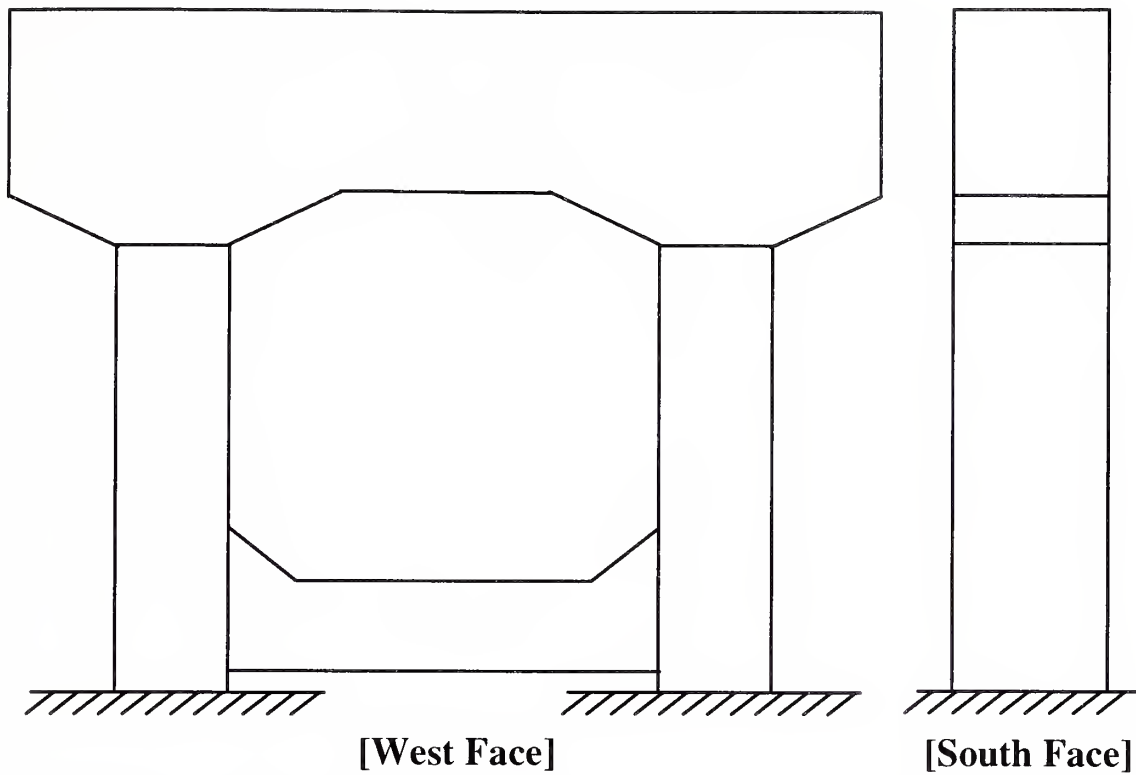
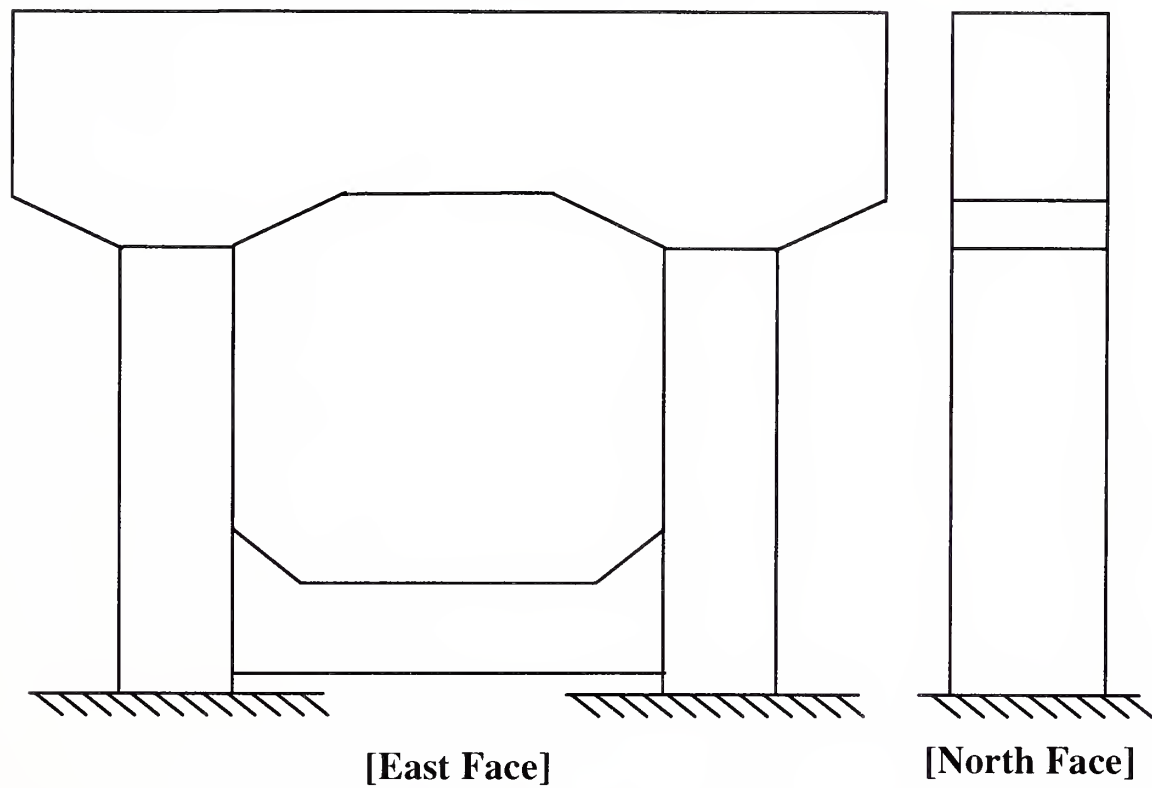
Figure 18A. Condition of Bent No. 19 (East Bound).

Damage	Location	Face	Description of Damage (No.)	Leakage Condition: Moist below beams 2-5  Test Performed: None
			<b>No Damage Observed</b>

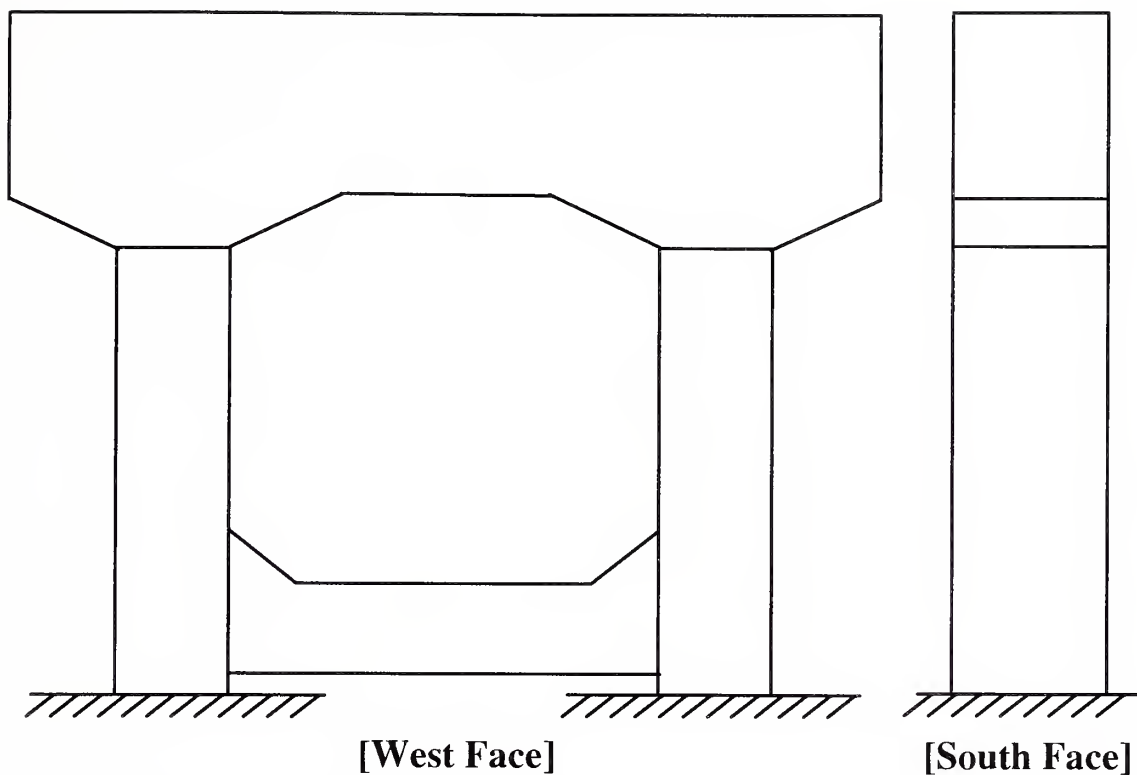
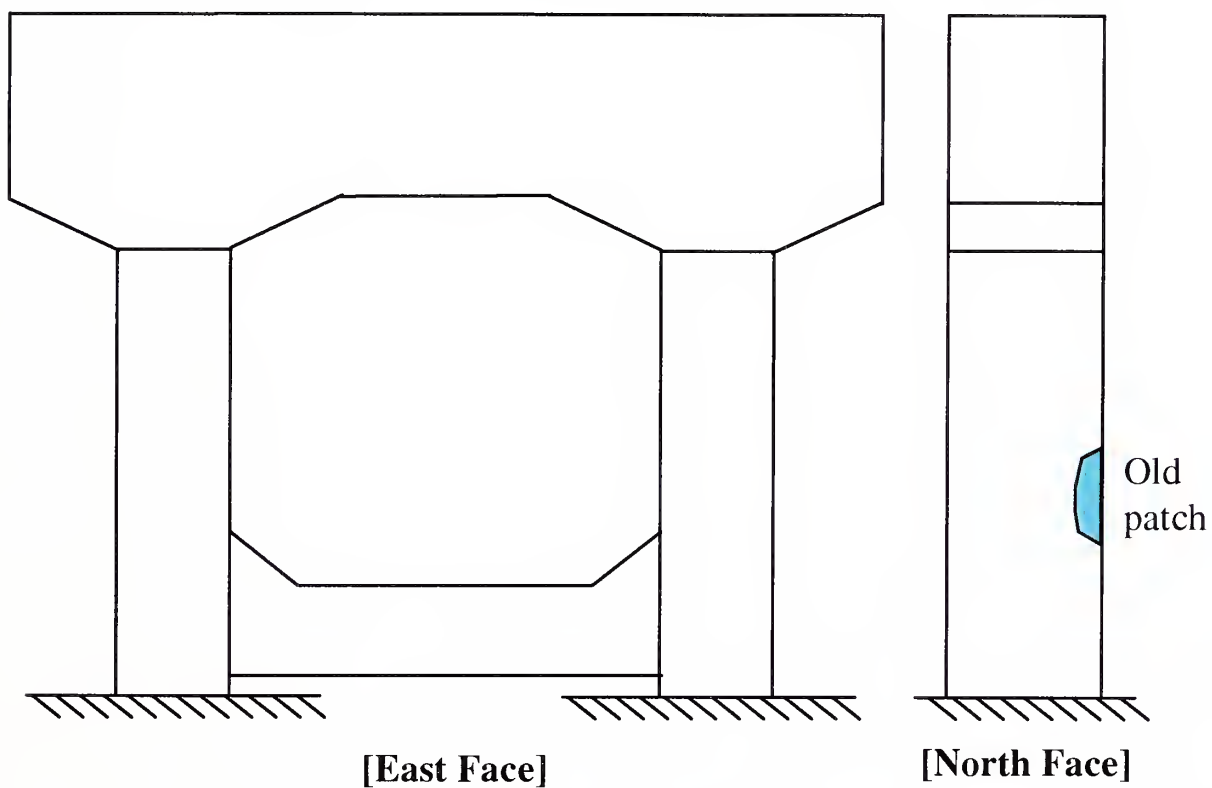
Figure 19A. Condition of Bent No. 20 (East Bound).

Damage	Location	Face	Description of Damage (No.)	Leakage Condition: Moist below beams 2-5  Test Performed: None
			<b>No Damage Observed</b>

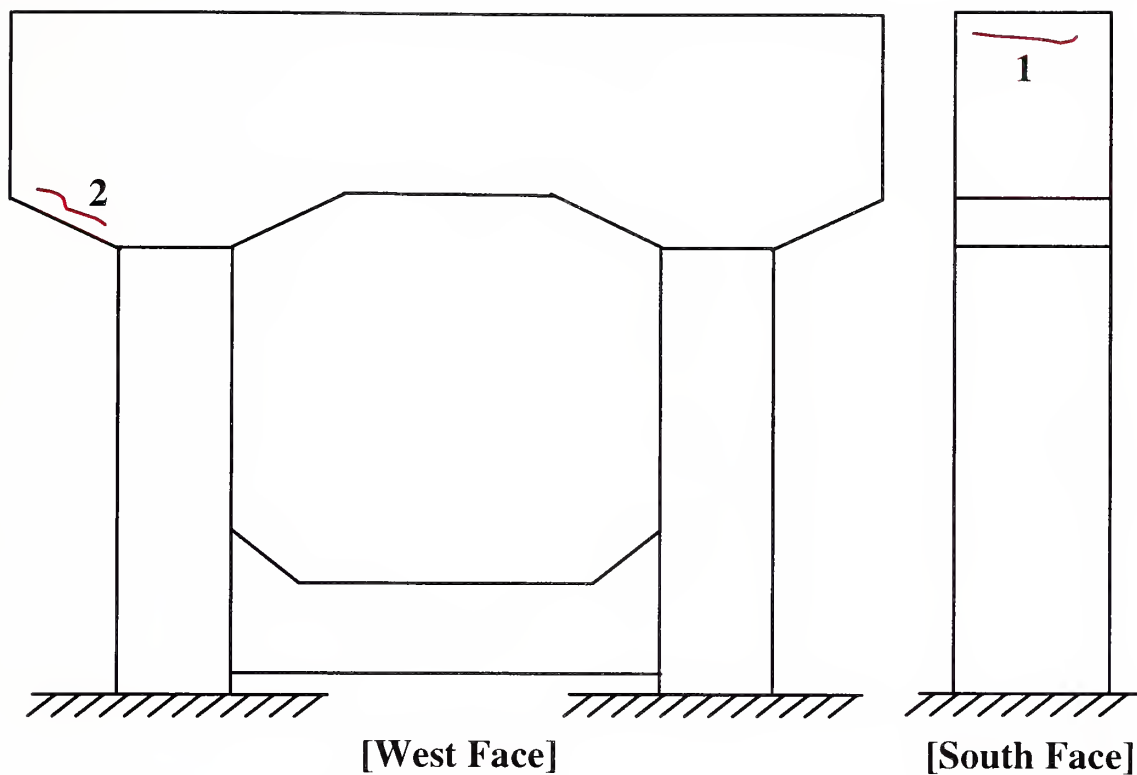
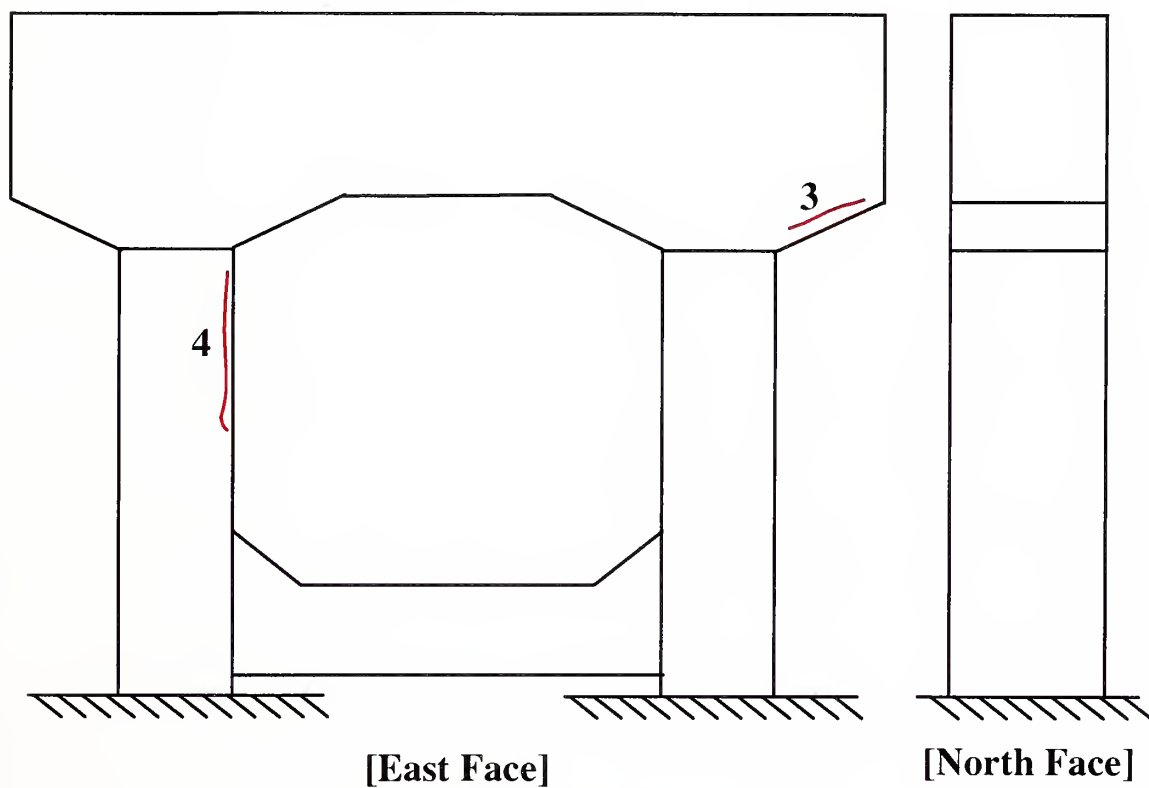
**Figure 20A. Condition of Bent No. 21 (East Bound).**

Damage	Location	Face	Description of Damage (No.)	Leakage Condition: No leakage but dry stains
	S. Col.	South	A crack and dry stains (1)	
	Cap	West	A crack (2)	Test Performed: None
	Cap	East	A crack (3)	
	S. Col.	East	A crack along the edge(4)

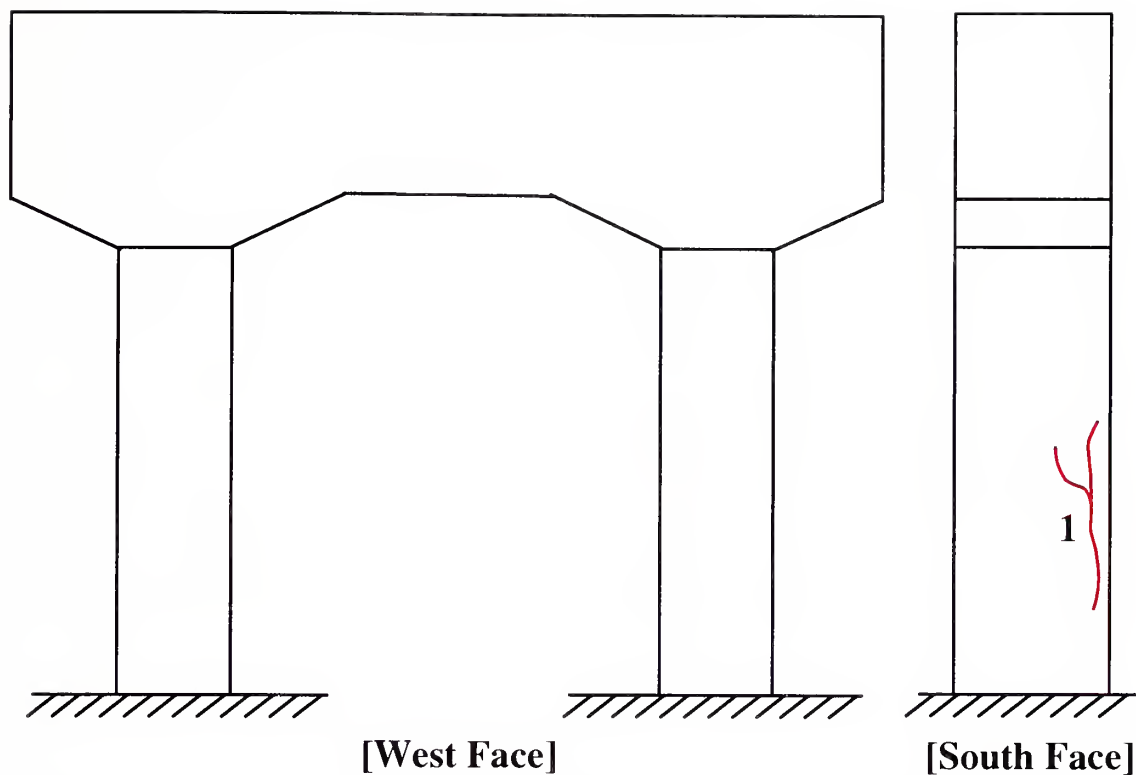
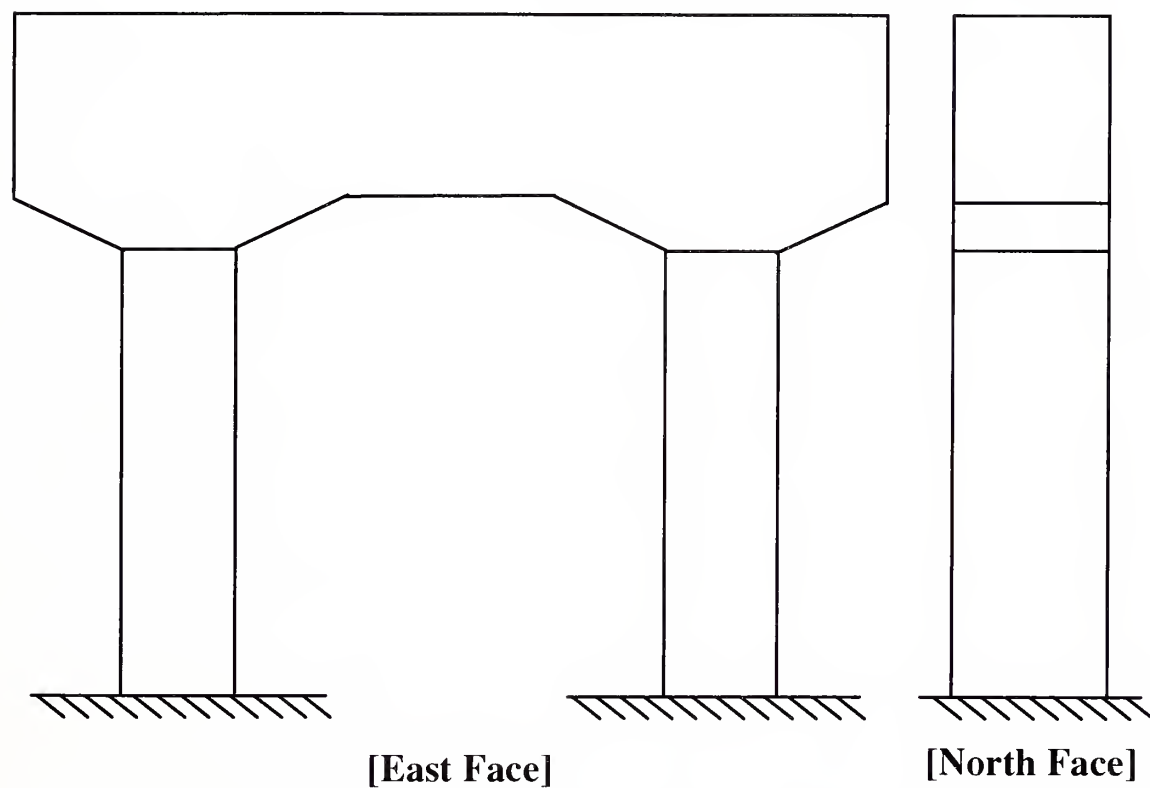
Figure 22A. Condition of Bent No. 23 (East Bound).

Damage	Location	Face	Description of Damage (No.)	Leakage Condition: Joint moist, lots of dry stains on cap  Test Performed: None
	S. Col.	South	Two crack at SE corner (1)

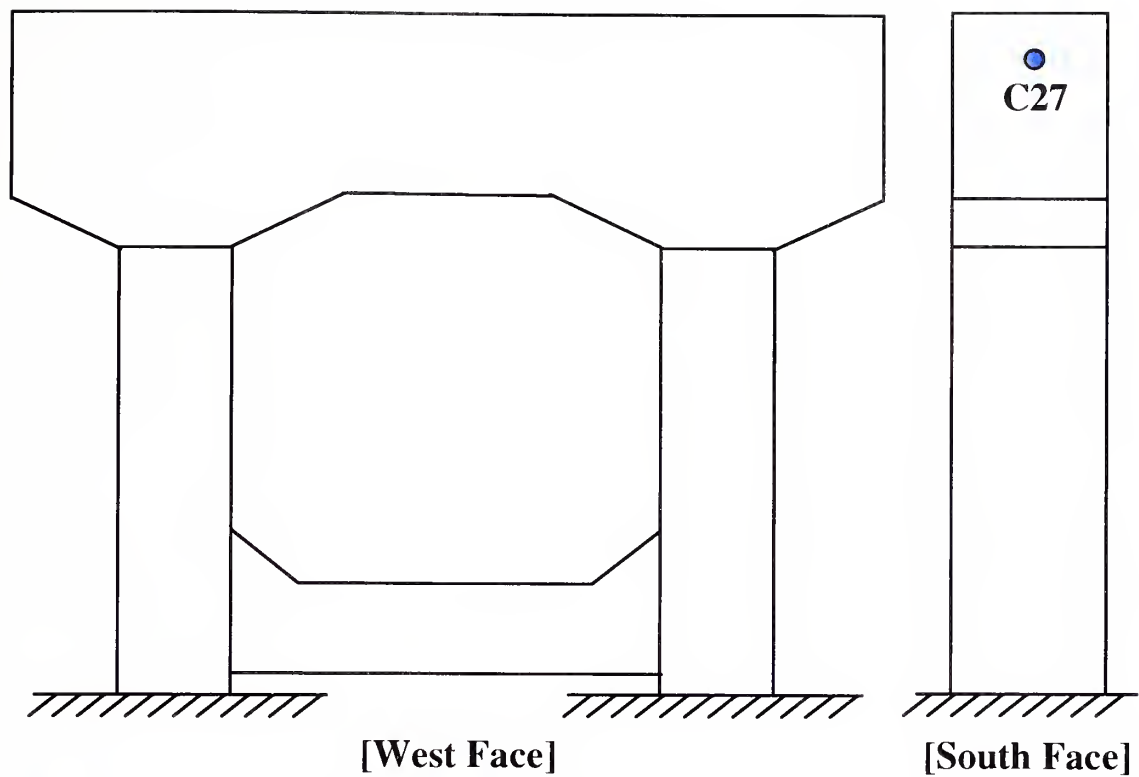
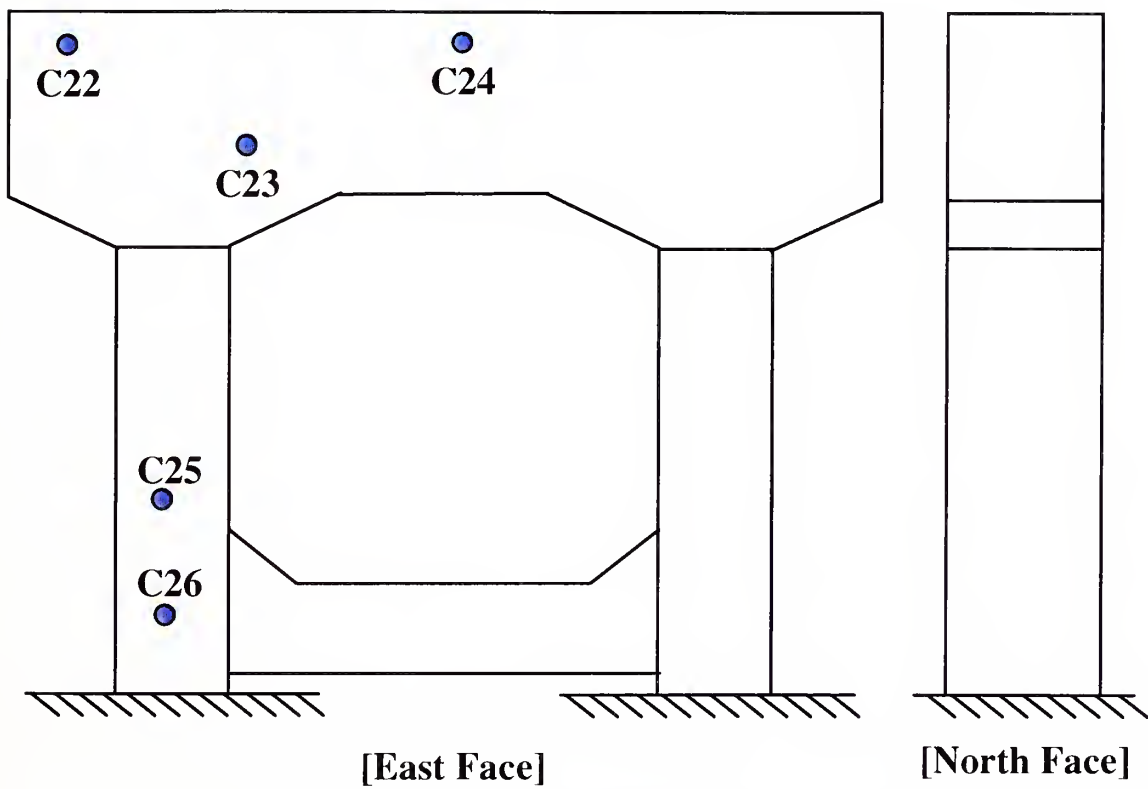
Figure 23A. Condition of Bent No. 24 (East Bound).

Damage	Location	Face	Description of Damage (No.)	Leakage Condition: No Leakage  Test Performed: Cores: 22-27
			<b>No Damage Observed</b>

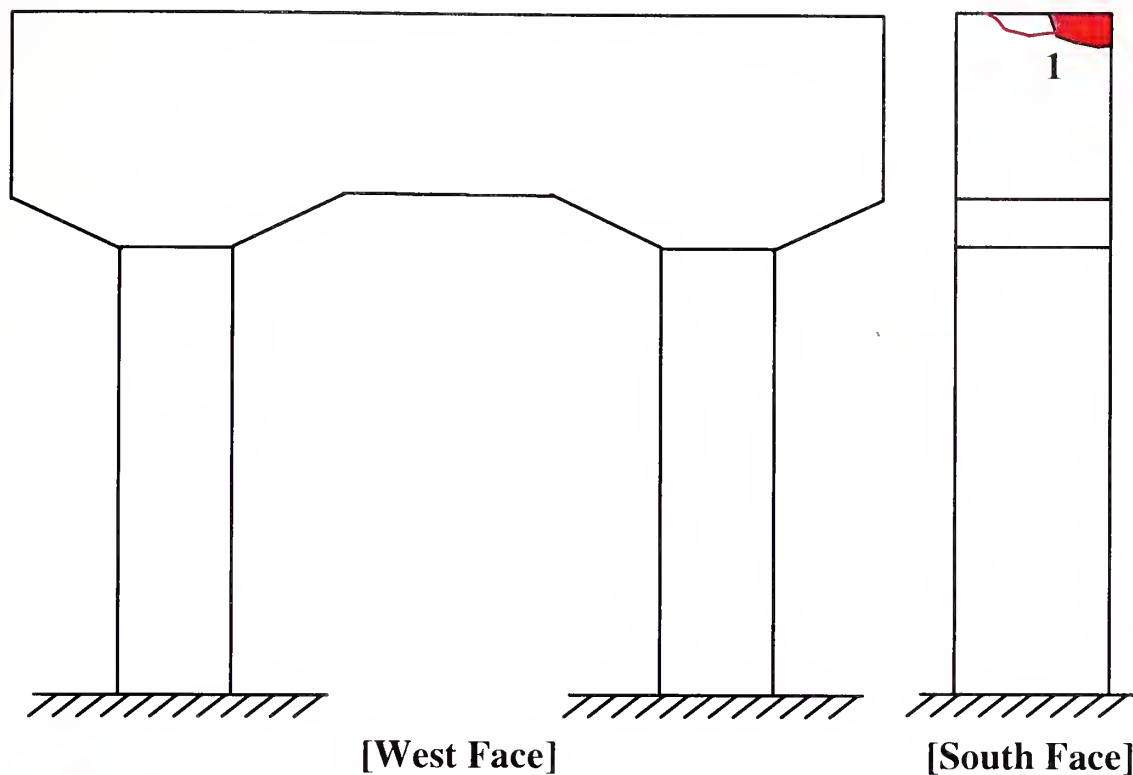
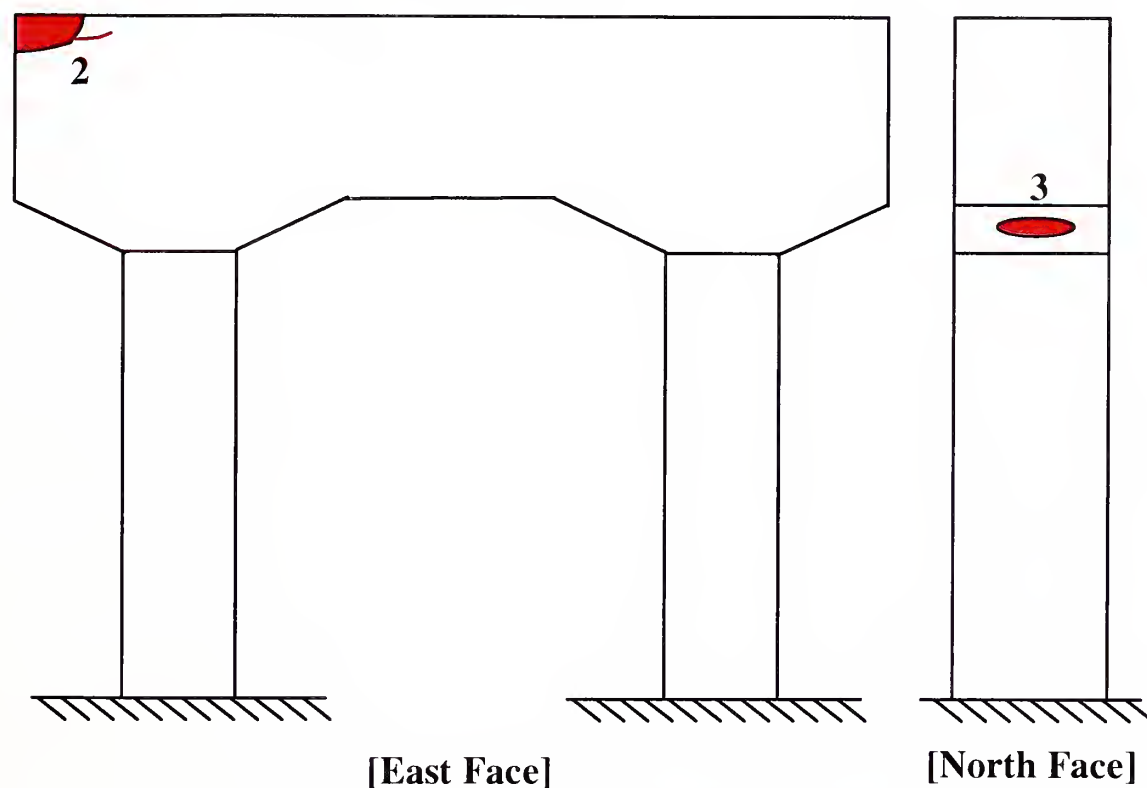
Figure 25A. Condition of Bent No. 26 (East Bound).

Damage	Location	Face	Description of Damage (No.)	Leakage Condition: No Leakage  Test Performed: None
	S. Col.	South	Small spall and a crack (1)	
	Cap	East	Small spall and a crack (2)	
	N. Col.	North	Small spall (3)

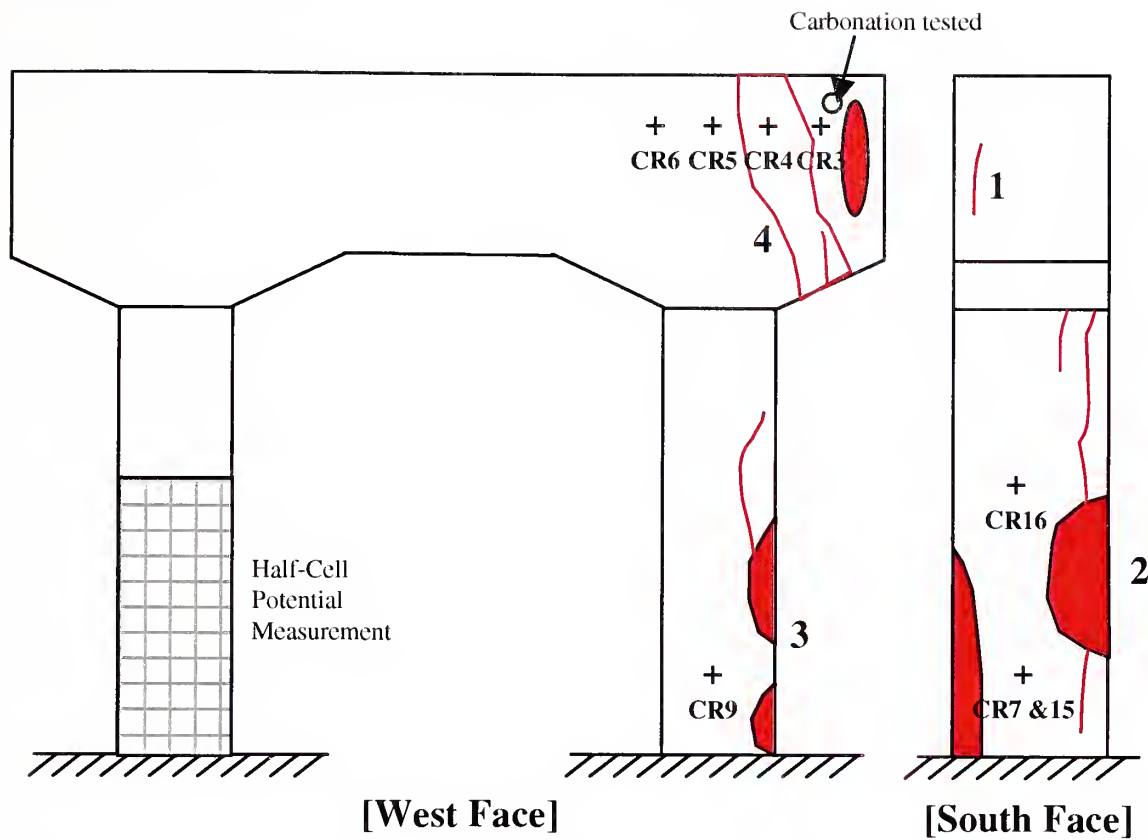
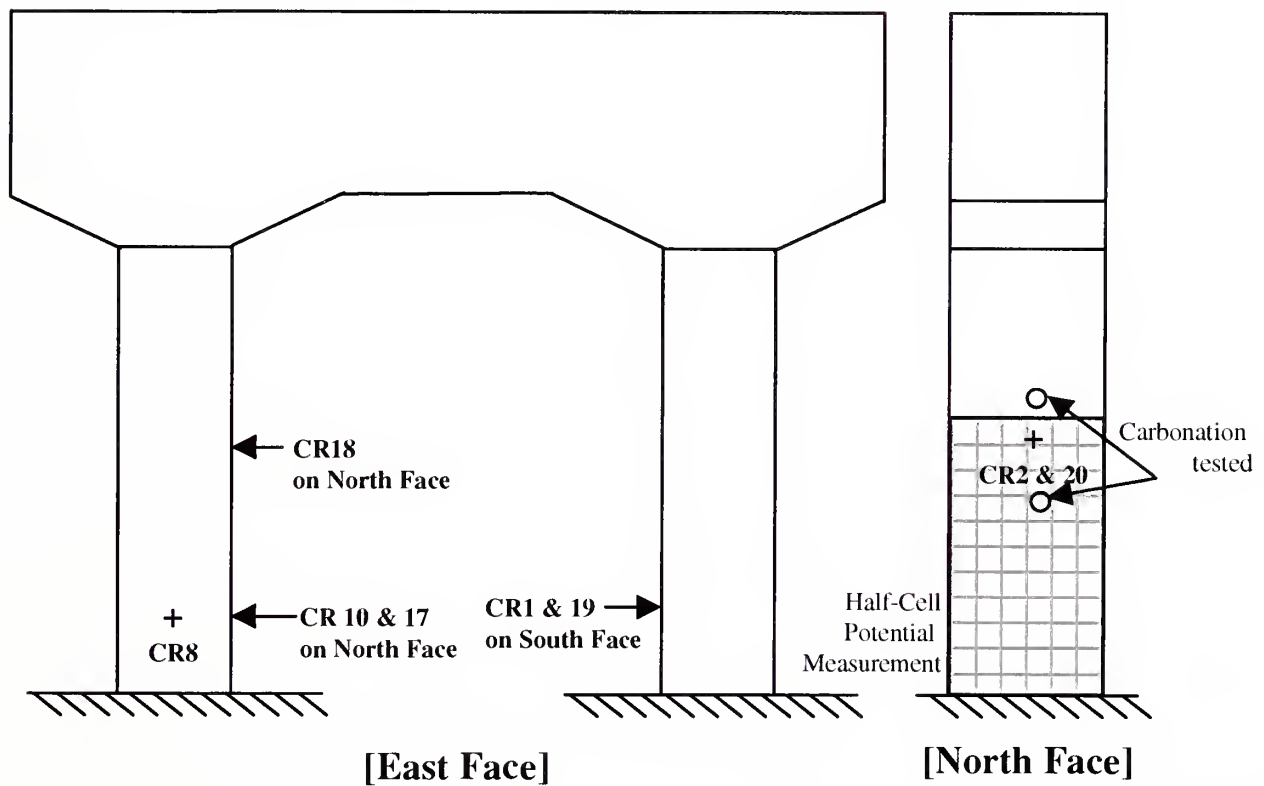
**Figure 26A. Condition of Bent No. 27 (East Bound).**

Damage	Location	Face	Description of Damage (No.)	Leakage Condition: Wet under beams 4-5 Test Performed: - CR1-10, & 15-20 - Carbonation Test at 3 locations - HCP measurement on 2 faces
	Cap	South	A crack (1)	
	S. Col.	South	Two spalls and three cracks (2)	
	S. Col.	West	Two spalls and a crack (3)	
	Cap	West	A spall, a delam. and a crack (4)
